Manhole Inspection Summary

Manhole # S55M__012MH

Insp Date: **6/5/08 8:51 AM**

Location Address: **3610 dillon st**

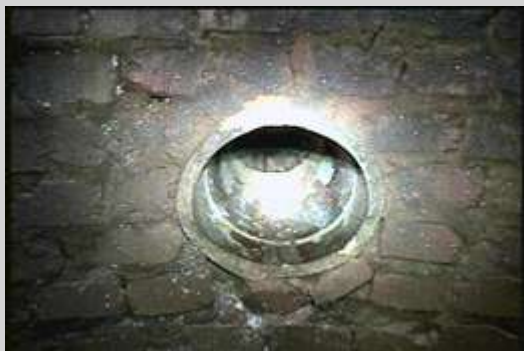
3 O'Clock Inflow

Pipe Height: 0 (in.) Direct

Pipe Material: Clay ☐ Pipe Lined

Invert Depth: 7.10 (ft.) Flow Characteristics: None

Deposits: ☒ None ☐ Mud ☐ Sludge ☐ Debris ☐ Grease

Infiltration: None Pipe Seal Cond: Unknown

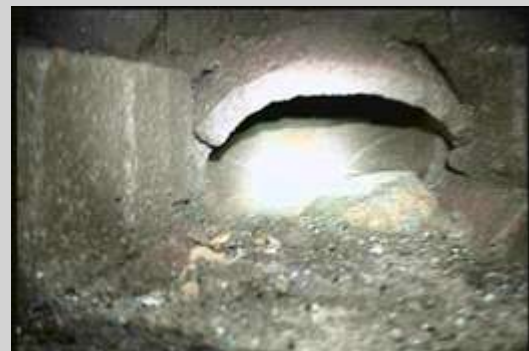
Drop In @ 3 O'Clock

Drop: Outside Direct

Inv Depth: 8.80 (ft.)

Drop Condition: Open

Connects To: Dead End

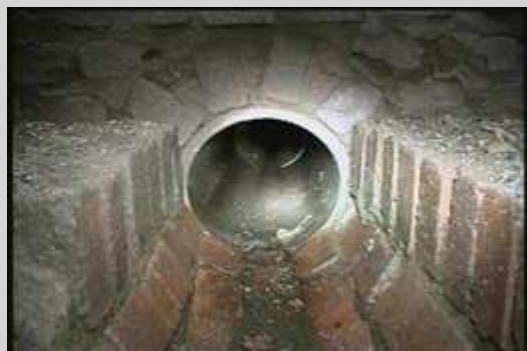
6 O'Clock Inflow

Pipe Height: **0** (in.) Direct

Pipe Material: **Clay** ☐ Pipe Lined

Infiltration: **None** Pipe Seal Cond: **Unknown**
